**EXPERIMENTAL MAINTENANCE PAINTING
OF I-65 IN LOUISVILLE
FEDERAL AID RESEARCH TASK NO. 108**

Research Report
KTC-02-25/FR108-01-1F

October 2002

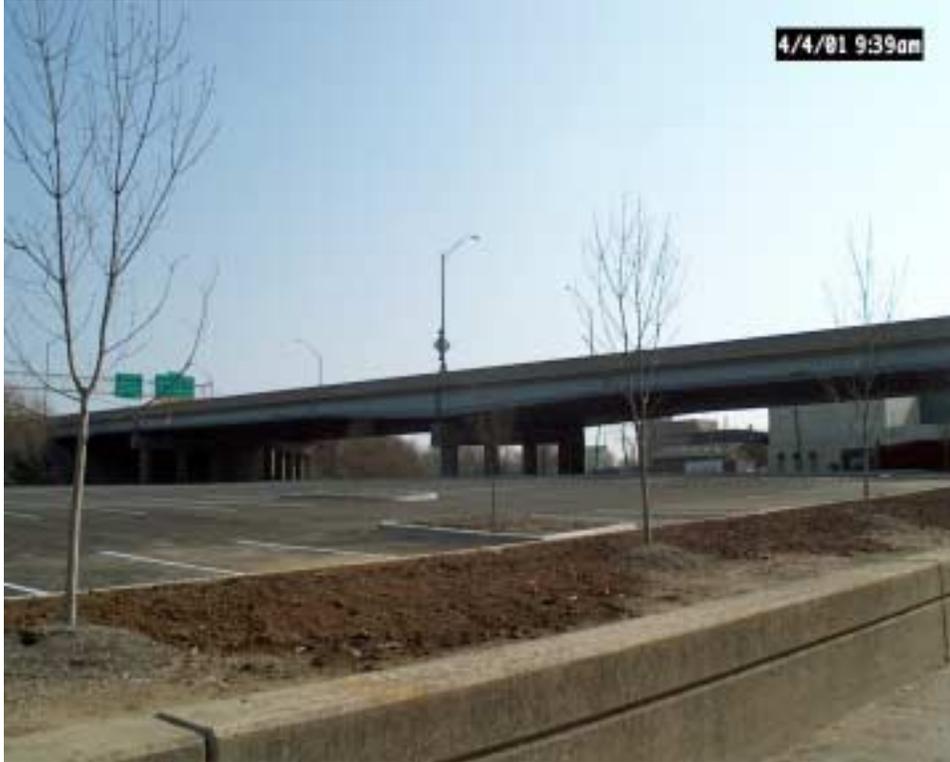
Figure 1. Overall view of Main Street Bridge before the painting started.

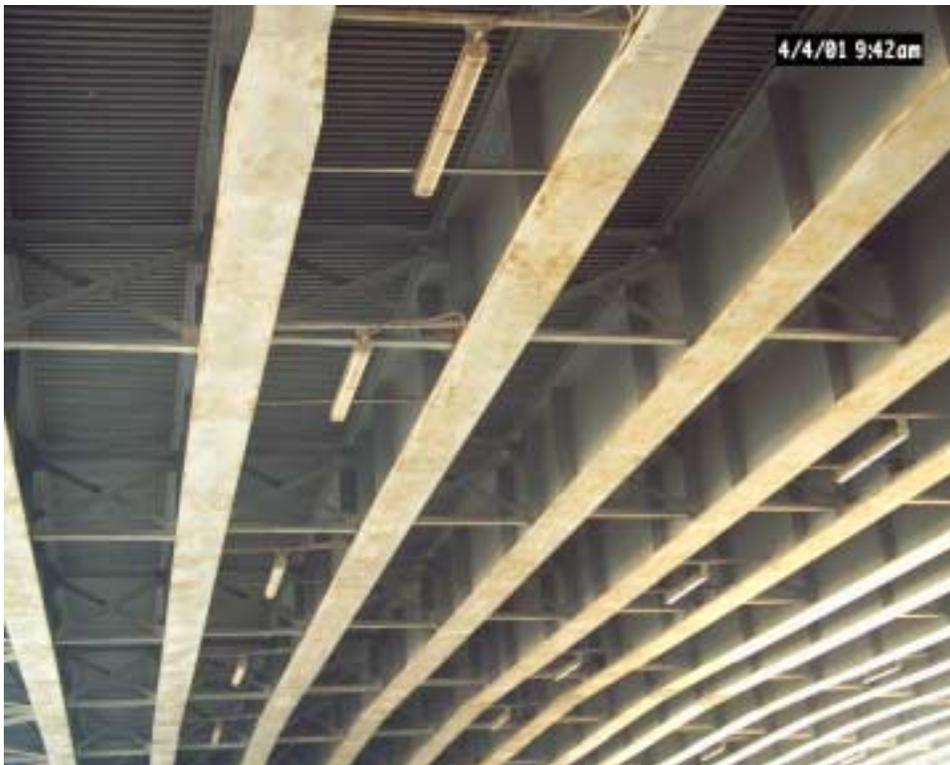
Figure 2. Close up of the composite girders of Main Street Bridge before painting.

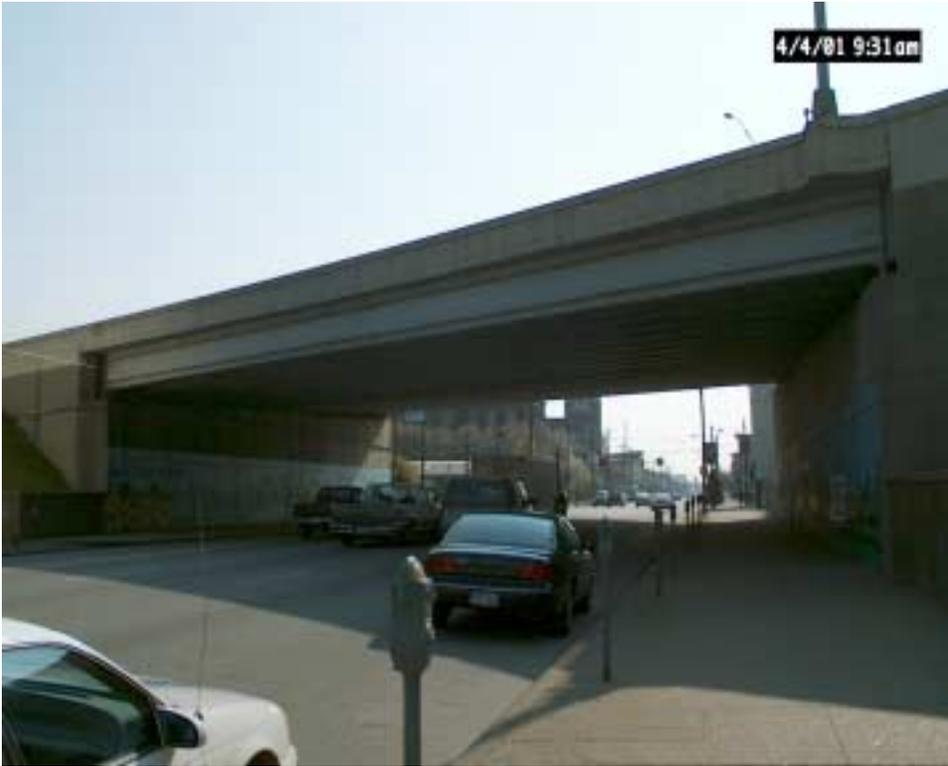
Figure 6. Overall view of the Market Street Bridge before painting.

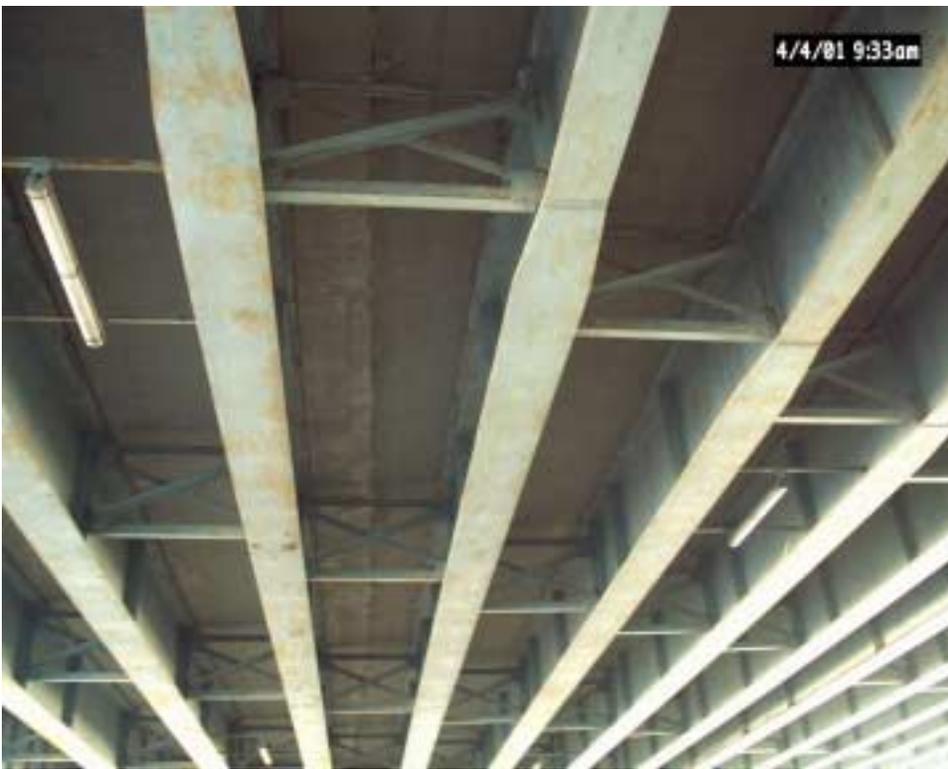
Figure 7. View of the girders before painting.

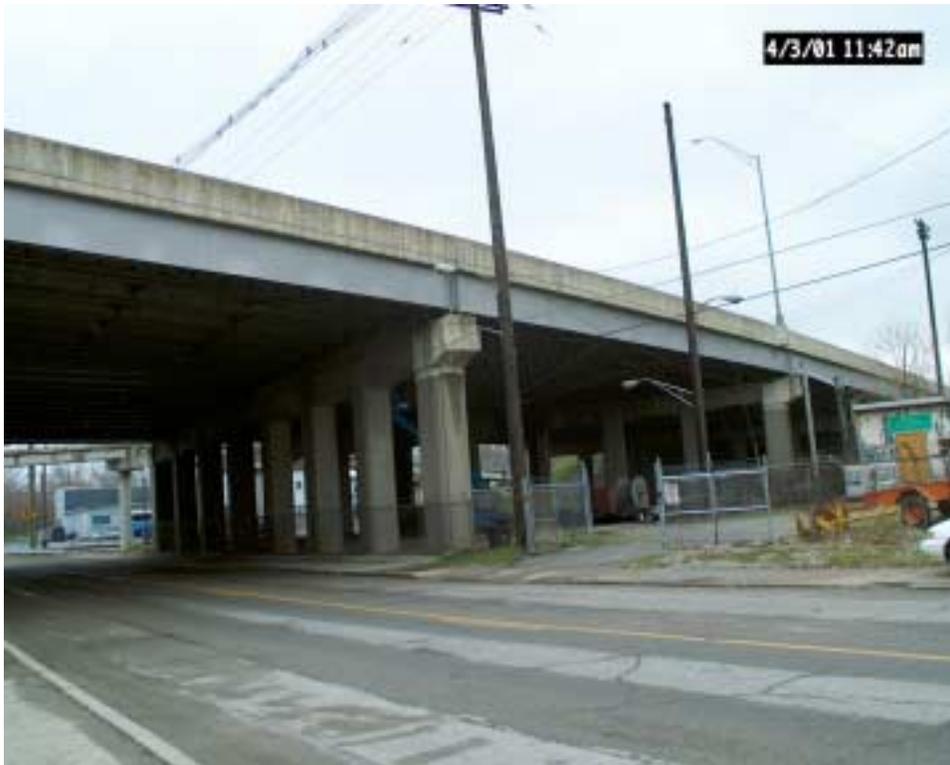
Figure 75. View of bridge at Burnett and Hill Street before painting.

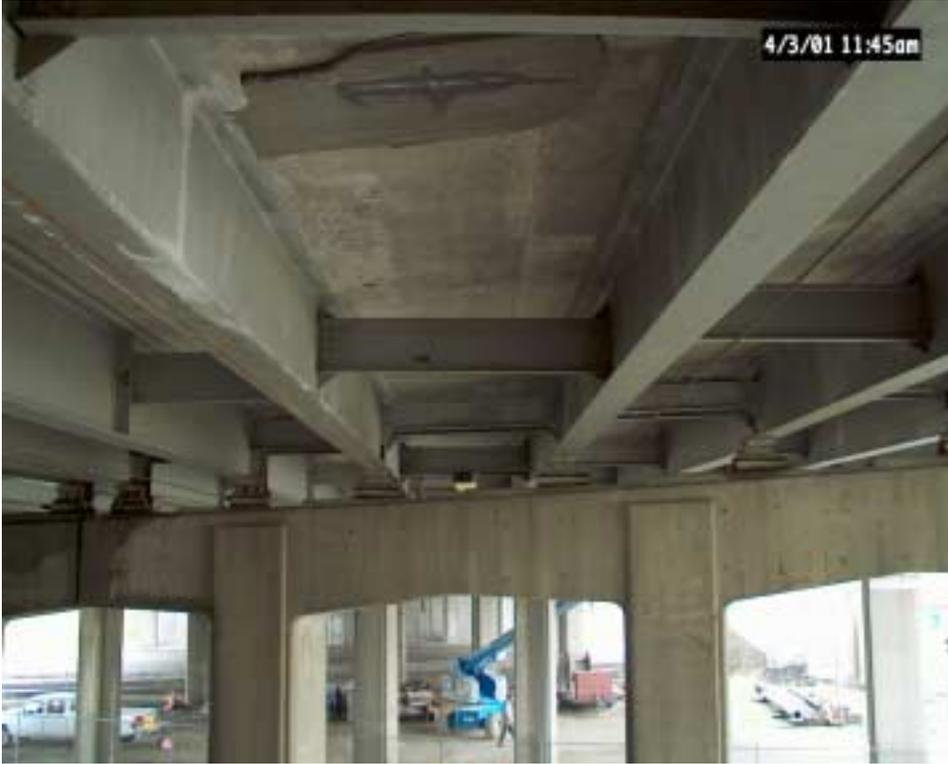
Figure 77. View of girders at Burnett and Hill Street Bridge before painting.

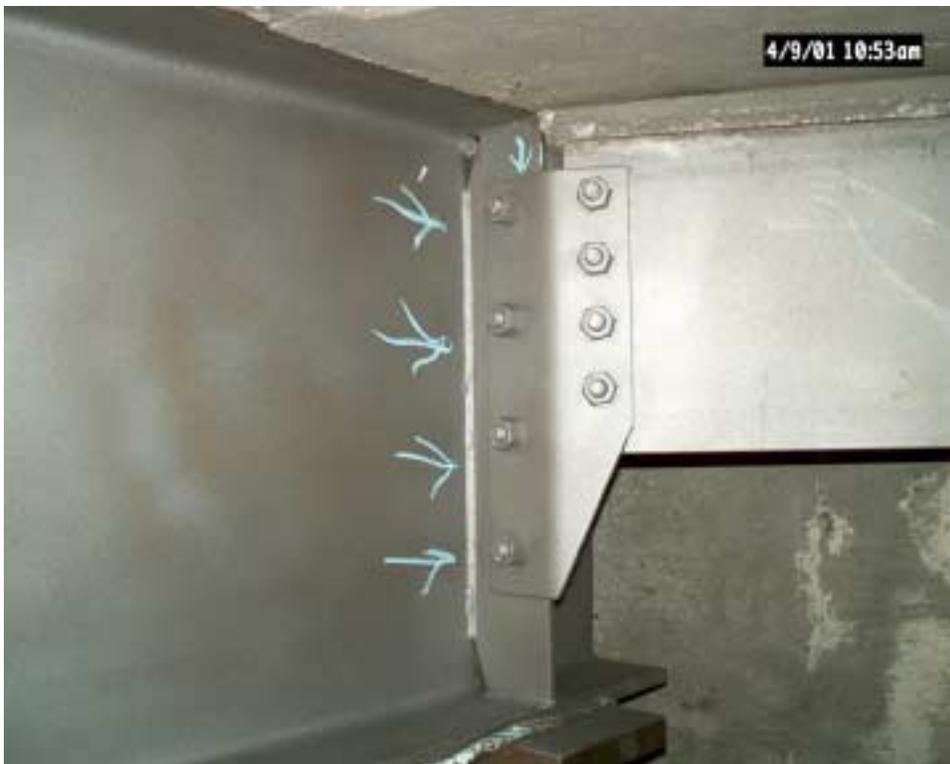
The mandatory test patch for the whole project was done on this bridge, with the contractor beginning the blasting operation on April 6, 2001. On April 9, 2001 the organic zinc rich primer was applied at 5.0 to 6.0 mils wet film thickness (WFT) by spraying. The following day, the intermediate coat of tinted moisture cure aluminum polyurethane was applied by spraying at 4.0 to 6.0 mils WFT. The next morning, the finish coat was applied at 4.0 to 6.0 mils WFT. The finish coat was to be acrylic polyurethane. Later that afternoon, the test patch was approved. The contractor continued painting rest of that structure.

Figure 103. View of the Manning Street Bridge where the prime coat of the test patch was applied.
